PISCATAQUA RIVER BASIN  
WAKEFIELD, NEW HAMPSHIRE

UNION MEADOWS DAM  
N.H. 00222

PHASE I INSPECTION REPORT  
NATIONAL DAM INSPECTION PROGRAM

Identification No.: NH00222  
Name of Dam: Union Meadows Dam  
Town: Wakefield  
County and State: Carroll County, New Hampshire  
River: Branch River  
Date of Inspection: September 19, 1979

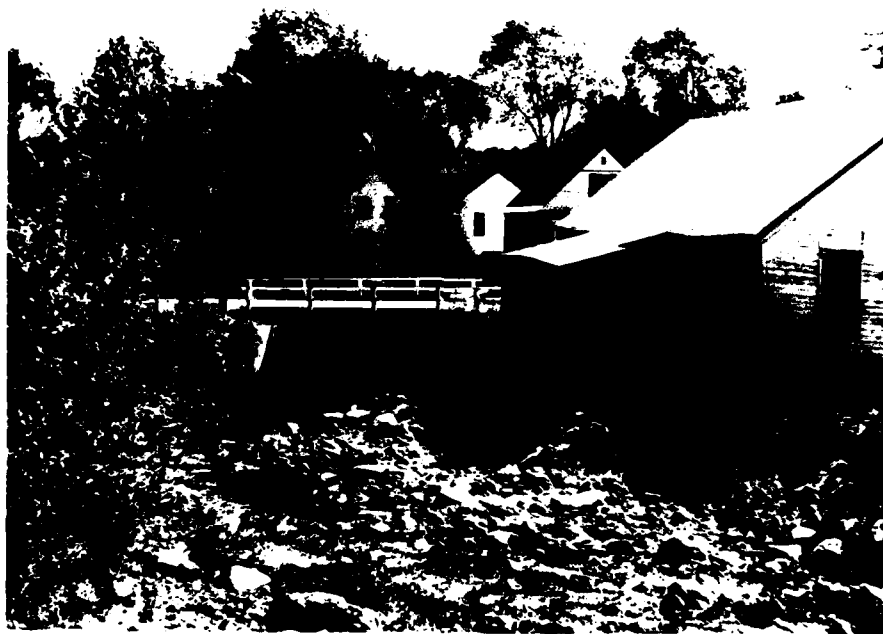
September 19, 1979  
Figure 13 - Looking south at Reach 3 downstream of  
Dam "A".

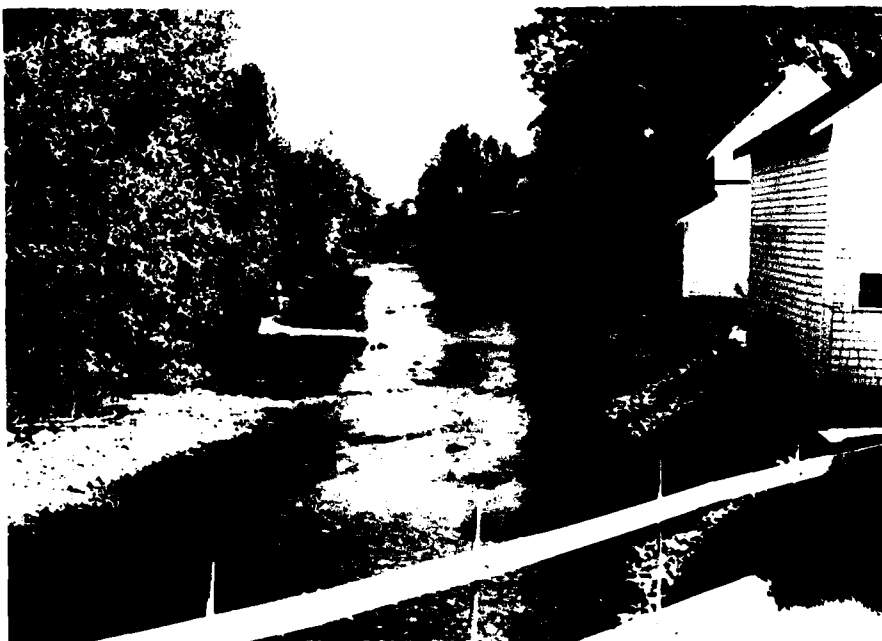
September 19, 1979  
Figure 14 - Looking southeast at Reach 4 downstream  
of Maple Street.
